Sustainable Slip Resistance: An Opportunity for Innovation

Carl J Strautins

Slip Check Pty Ltd, Sydney Australia
carl.strautins@gmail.com

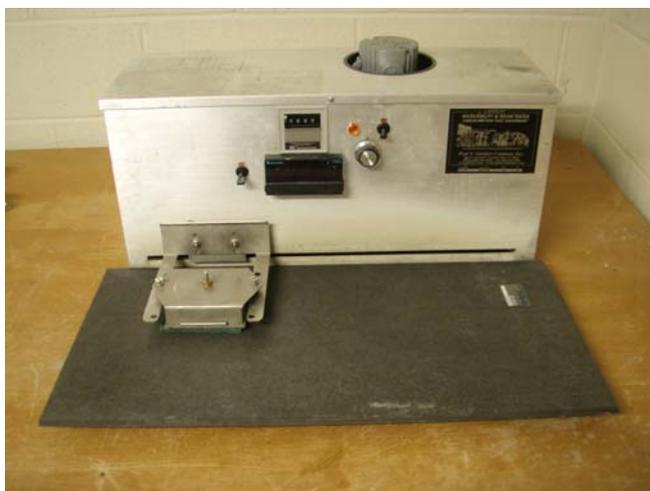
(a) Gardco linear motion washability and wear tester

Figure 1. Initial investigation of test methodology using: (a) Gardco linear motion washability and wear tester; and (b) Pendulum slip resistance friction tester

A Gardco 12VFI linear motion washability and wear tester was used to develop an accelerated wear test. This apparatus has traditionally been used to assess the wear resistance of paint systems using nylon bristle brushes. The machine has a 100mm x 100mm friction boat, which is cradled within a fork drive. Different abrasive materials were fixed to the bottom of the friction boat, which was set to operate at a rate of 50 cycles per minute, traversing backwards and forwards over a 300 mm path length. The pressure on the (water) wetted test specimen was controlled by adjusting the friction boat weight.

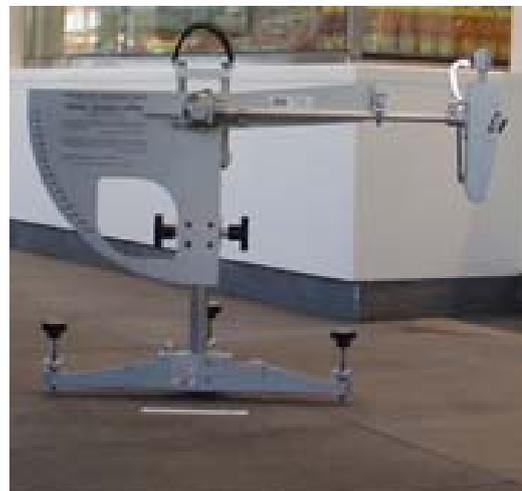
(b) Pendulum slip resistance friction tester

Initially the effect of the abrasive material and the applied pressure was investigated using a dust pressed, glazed ceramic tile. Four grades of 3M nylon cleaning pads were used for the study. They are identified by colour, in order of ascending abrasiveness: White - Light Duty No.98, Blue Fine -Power Pad No.2000, Green - Heavy Duty No.86, Dark Blue - Extra Heavy Duty No.88. These abrasive pads were used in combination with three weights of 500 g, 1000 g and 2000 g. A batch of 40 ceramic tiles were tested to AS/NZS 4586 using the wet pendulum with Four S (Slider 96) rubber material conditioned with P400 Grade abrasive paper, allowing tiles

which measured a dynamic coefficient of friction (DCOF) of 0.59 to be selected for accelerated wear testing. The DCOF was re-measured after every 50 wear cycles to a total of 1000 cycles.

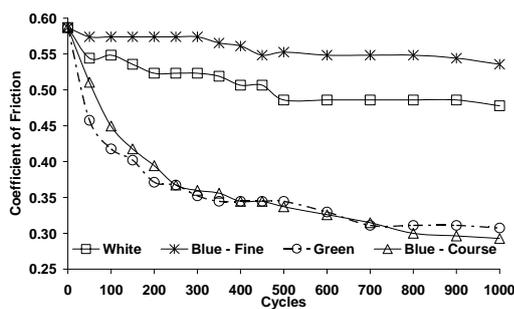
(a) Comparison of 4 abrasive pads

Figure 2. Initial investigation of test methodology using tile 1: (a) 4 different abrasive pads with 1000 g weight; and (b) Green Scotch Brite pad with 3 weights

The results are shown graphically in Figure 2. Figure 2(a) depicts the relative difference between the 4 abrasive pads. While the white and fine blue abrasive pads resulted in slight ongoing changes in slip resistance, there was a more pronounced change with the coarse green and blue abrasive pads. The green pad was then used to evaluate the effect of applied pressure (500 g, 1000 g and 1500 g weights) as depicted in Figure 2 (b). No significant difference was observed between the 1000 g and 1500 g weights. The green pad was easier to mount to the friction boat than the coarser blue pad. The green 3M Scotch-Brite abrasive pad was thus selected with a 1000 g weight for accelerated wear use in an extensive range of further sustainable slip resistance studies.

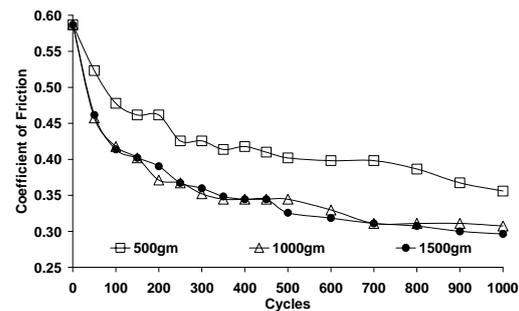
(b) Comparison of 3 different weights

The initial investigation of an accelerated wear test procedure indicated that a 3M green Scotch-Brite abrasive pad with weight of 1000gm, with rate of 50 cycles per minute over a 300mm path length was suitable for determining the loss in slip resistance using the pendulum friction tester. There was a noticeable smoother texture when the abraded tile was felt by hand, however the change was not detected using surface roughness parameter Rz. The greatest loss of slip resistance generally occurred during the first 50 cycles, with comparatively little loss after 500 cycles. The slip resistance after 500 cycles was found to be consistent with the in situ measurements at a high traffic volume restaurant after one year of usage. Thus a DCOF greater than 0.35 after 500 cycles appears to be a logical benchmark for new tiles that are likely to be used in similar high traffic usage scenarios.

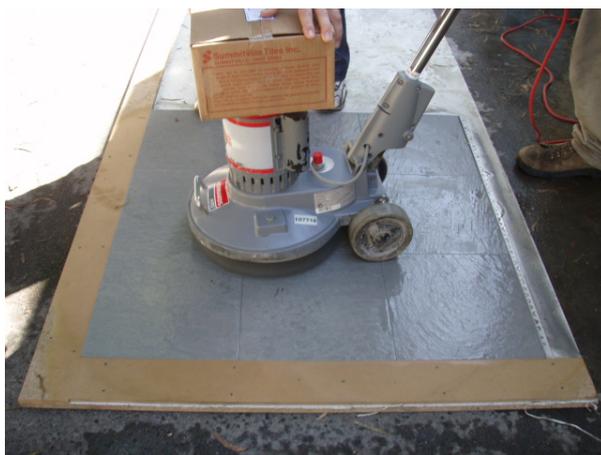
(a) Polishing/buffing machine used to wear tiles

Figure 3. Apparatus used for preparation and testing of samples for the inclining ramp test method.

Samples were first exposed to 5000 cycles of the accelerated Gardco wear procedure. The slip resistance was measured using the wet pendulum test method using both potable water and (the DIN 51 030 specified) oil. 0.5m² samples of each tile were then mounted separately on a board and subjected to wear using a floor polishing/buffing machine using a variety of abrasive cleaning pads. The position of the tiles on the board was changed during the procedure in an attempt to wear each of the tiles uniformly. The tiles were tested periodically using the pendulum friction tester (Slider 96) until the slip resistance had reduced equivalent to that of 5000 cycles of the accelerated wear procedure. Multiple measurements were conducted on each sample of worn tiles. Some minor variation may have occurred throughout the panels. One sample board was rejected as there was a difference in CoF between the Gardco accelerated wear samples and the polishing/buffing machine was greater than 0.02. The process was then repeated until the sample board conformed within ±0.02 CoF of the mean.

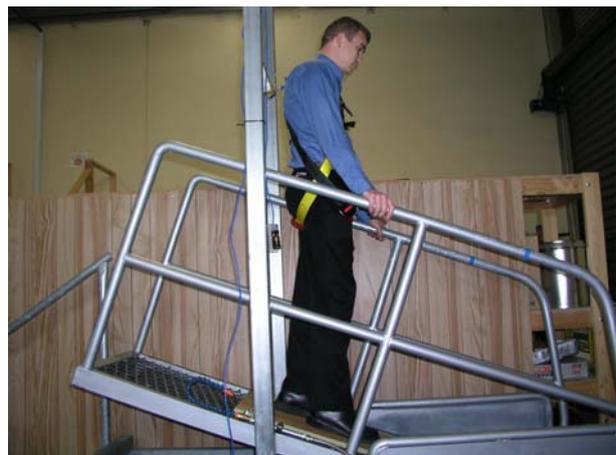
(b) Inclining ramp testing apparatus

Ramp testing was conducted at ATTAR test facilities located in Melbourne, Australia. The tangent of the ramp result angles (for one experienced walker only) were converted into coefficients of friction. The ramp tests with potable water (no wetting agent) were conducted with the walker wearing flat soled shoes that had been shod with Slider 96 rubber.

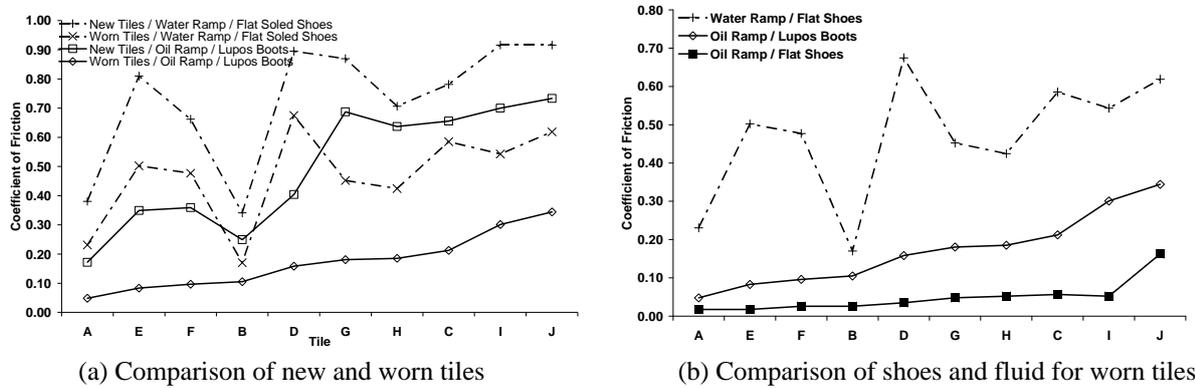
Figure 4. Investigation of inclining ramp test methodology (a) difference between new and worn tiles using water and oil for the ramp test; and (b) comparison of shoes used and contamination.

Figure 4(a) shows the results graphically of the coefficient of friction for both new and worn tiles using inclining ramp with water and flat soled shoes shod with slider 96 rubber prepared with P400grade paper. The standardised safety boots were not prepared with abrasive paper when ramp testing with oil as a contaminant. The results were ranked in an ascending order of worn tiles when tested to DIN 51 030. After the equivalent of 5000 cycles of wear the reduction in slip resistance was noteworthy. There was a reduction of between 25-50% when measured with the water ramp test and 53-75% with the oil wet ramp test.

Figure 4(b) shows the comparative difference in coefficient of friction between the three inclining ramp tests conducted after the equivalent wear of 5000 cycles. The relative difference between the results is due to the type of intermediate fluid, footwear soling material and tread pattern, since the friction mechanisms vary significantly in these situations. Different tribometers, operating on different principles, often give different results as an inherent function of the tribometer and, thus, may underestimate or overestimate the available traction in some circumstances.

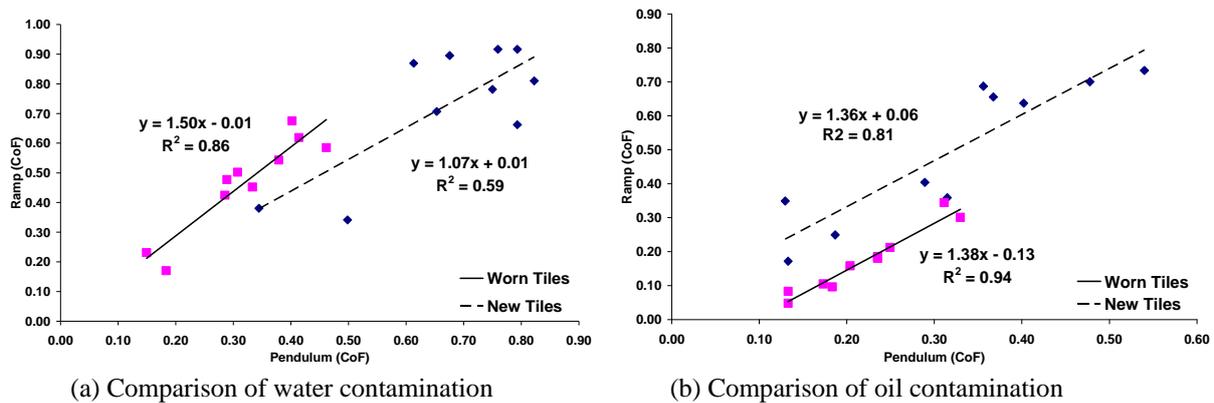
Figure 5. Plot of inclining ramp versus pendulum on both new and worn tiles using different lubricating mediums (a) water; and (b) oil.

Comparing both new and worn surfaces in water conditions, the pendulum generally underestimates the ramp results. If one assumes that the ramp test provides the best indication of the slip potential of products, one might conclude that any assessment of the likelihood of slipping should be based on derived ramp results. As studies have shown that there is a reasonable correlation between these conditions, a correction factor should be integrated within a quantitative risk assessment when utilising the pendulum. Assuming that the worn tile provides a truer indication and removes the sensitivity that either the ramp or pendulum may have, the following relationship was obtained for the diverse range of worn tiles tested;

$$\mu_{\text{Ramp water}} = 1.46 \mu_{\text{Pendulum water}} \quad (R^2 = 0.87)$$

Better agreement might be obtained for families of tiles which have similar surface characteristics. Any correction factor should be based on the relevant tile family, not a generalized one. Silva (2006) has shown that there is poor correlation between the oil wet ramp test and the water wet pendulum test using CEN rubber. This concurs with the results of this study using slider 96. Based on the ten ceramic tiles, a reasonable relationship was exhibited between the oil wet ramp test and the pendulum using oil;

$$\mu_{\text{Ramp oil}} = 1.32 \mu_{\text{Pendulum oil}} - 0.12 \quad (R^2 = 0.94)$$
